Test report

Product(Sample)	eArc module
Application Dept.	Production department
Applicant	Xiaowen Liu
Test Company	<u>SUNMAN(ZHENJIANG) CO.,LTD.</u>
Test Date	2021-11-12
Tester

To confirm the effect of eArc module's upper film creases on aging and long-term reliable performance.

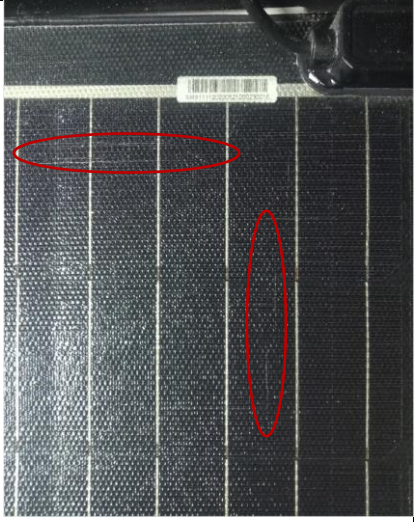
Normal

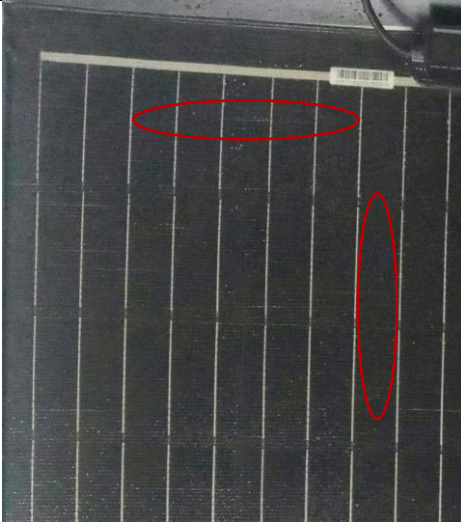
Color: Normal No obvious abnormalities on the creases area	Pass

After DH1000h, the power degradation is less than 5%, and no obvious abnormalities on the creases area, the power and wet leakage tests both meet the requirements;

Therefore, it is determined that the creases on the surface do not affect the performance, durability or reliability of the modules .

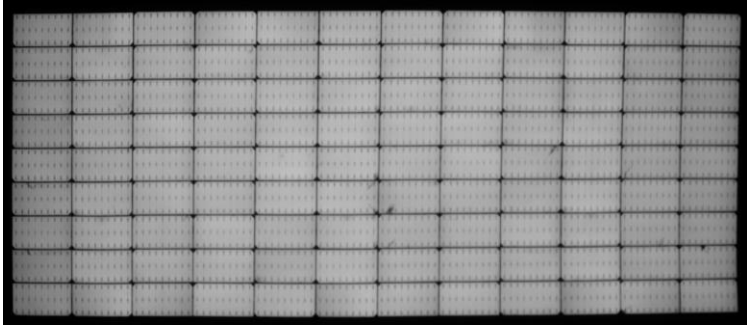
Normal	Pass

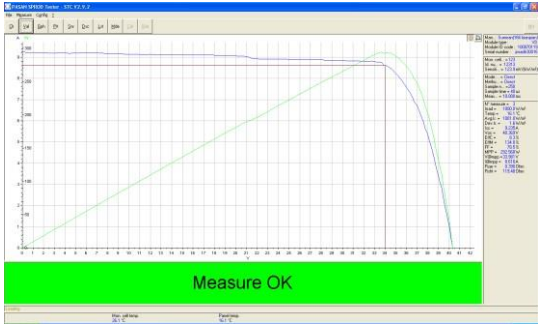
Power: 292.568W	Pass
	1* IEC

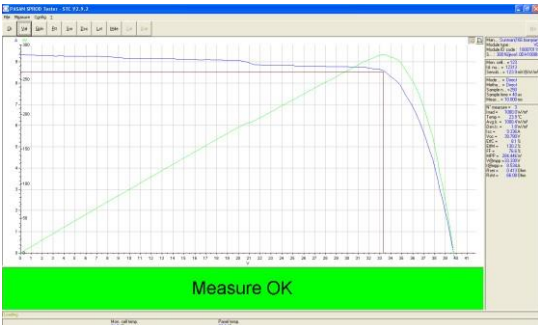
Power: 284.446W Degradation : -2.78%	Pass
